EVALUATION OF DOW CHEMICAL PRODUCTION EXTRUDED TRUSS-WEB LANDING MAT

D. W. White, Jr.

March 1974

Conducted by U. S. Army Engineer Waterways Experiment Station
Soils and Pavements Laboratory
Vicksburg, Mississippi

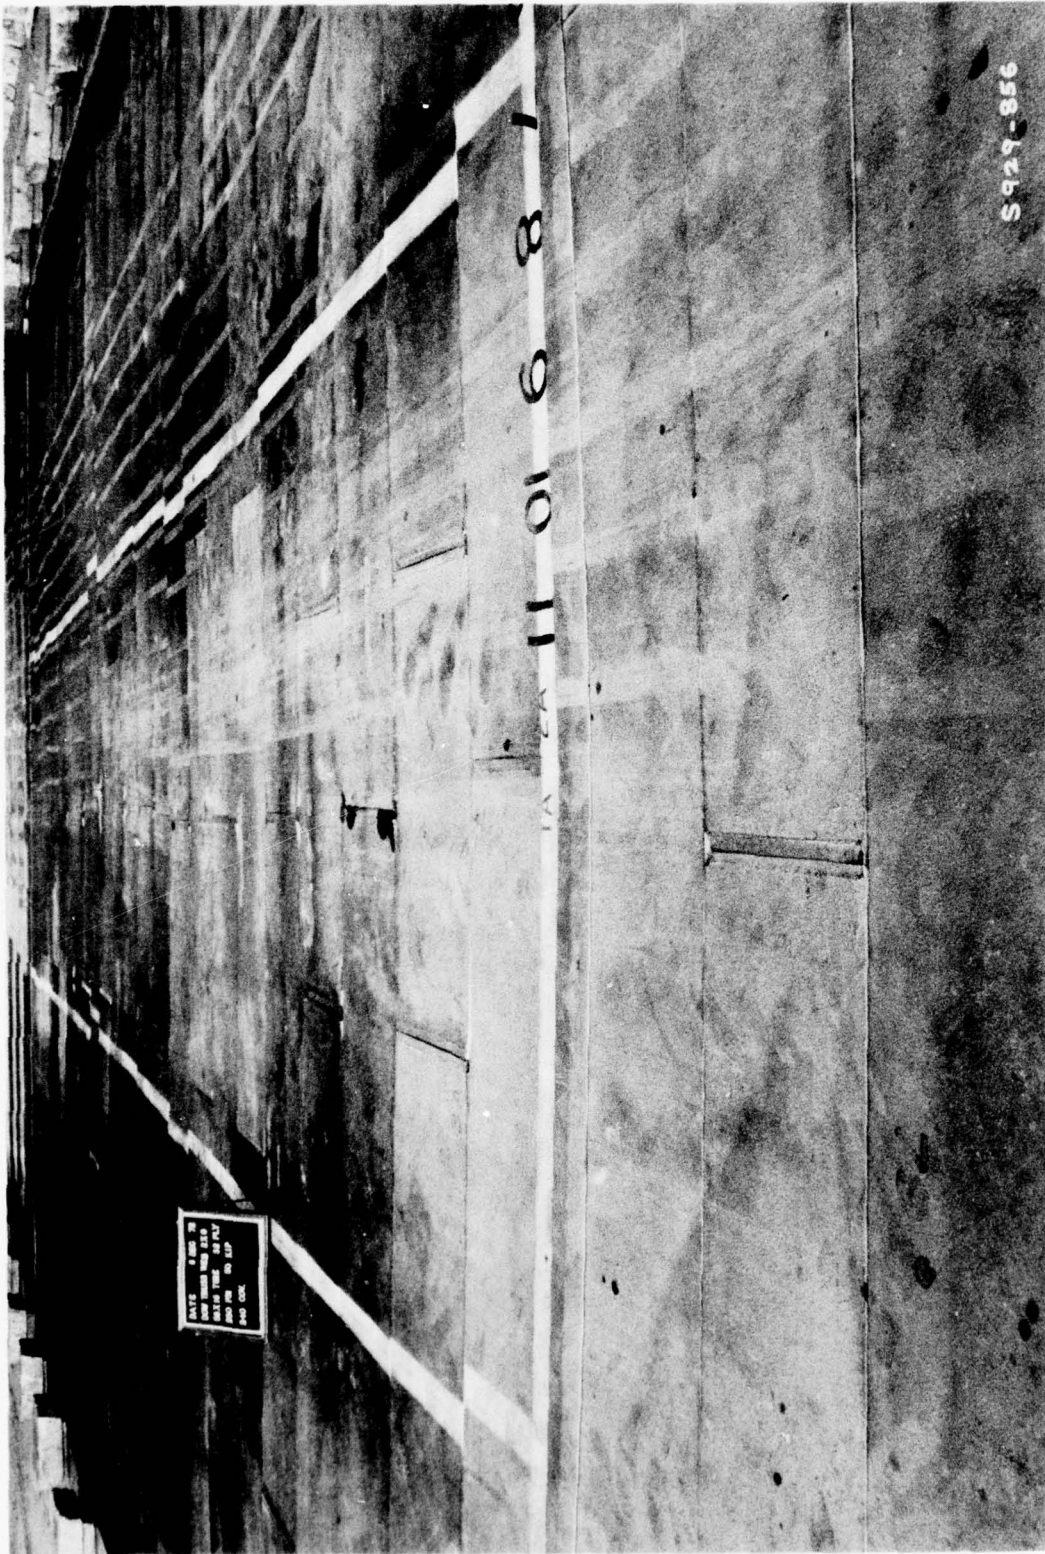
the center of panels where two end joints came together. Subgrade data taken at the end of the test (240 coverages) are given on Incl 6. It will be noted that the CBR at the end of the test was 4.2, thus giving a rated CBR of 4.0 for the test.

a. The mat sustained only 240 of the required 1000 coverages of the 50,000-lb SWL with a 250-psi tire-inflation pressure on a 4-CBR subgrade prior to failure of the mat due to splits along the female connectors at the panel corners.

Test section after 240 coverages

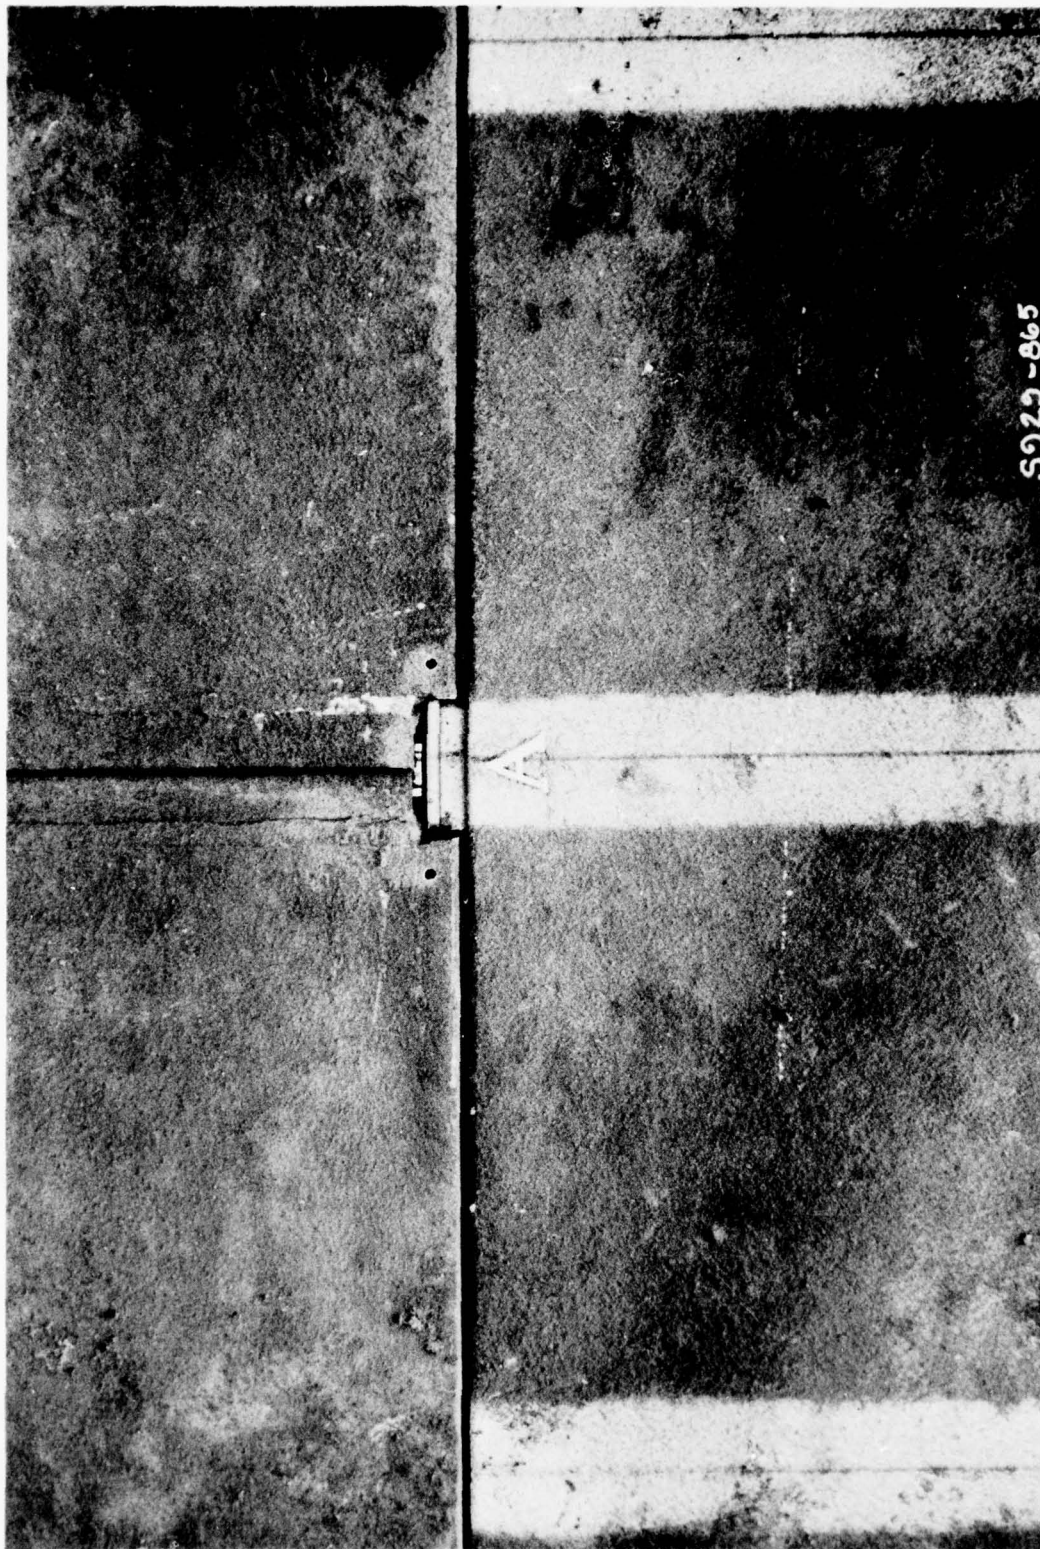
8. Channelized traffic with the same load used in the preceding test was applied on two lanes as shown on the layout. Subgrade data are shown on Incl 6. The first pair of panels (panels 33 and 40) with drilled holes were considered failed due to a tire hazard after 100 coverages due to a split along each female connector. The second pair of panels with drilled holes (panels 38 and 45) are shown on Incl 28 after

Pair of panels with drilled holes at the female corner

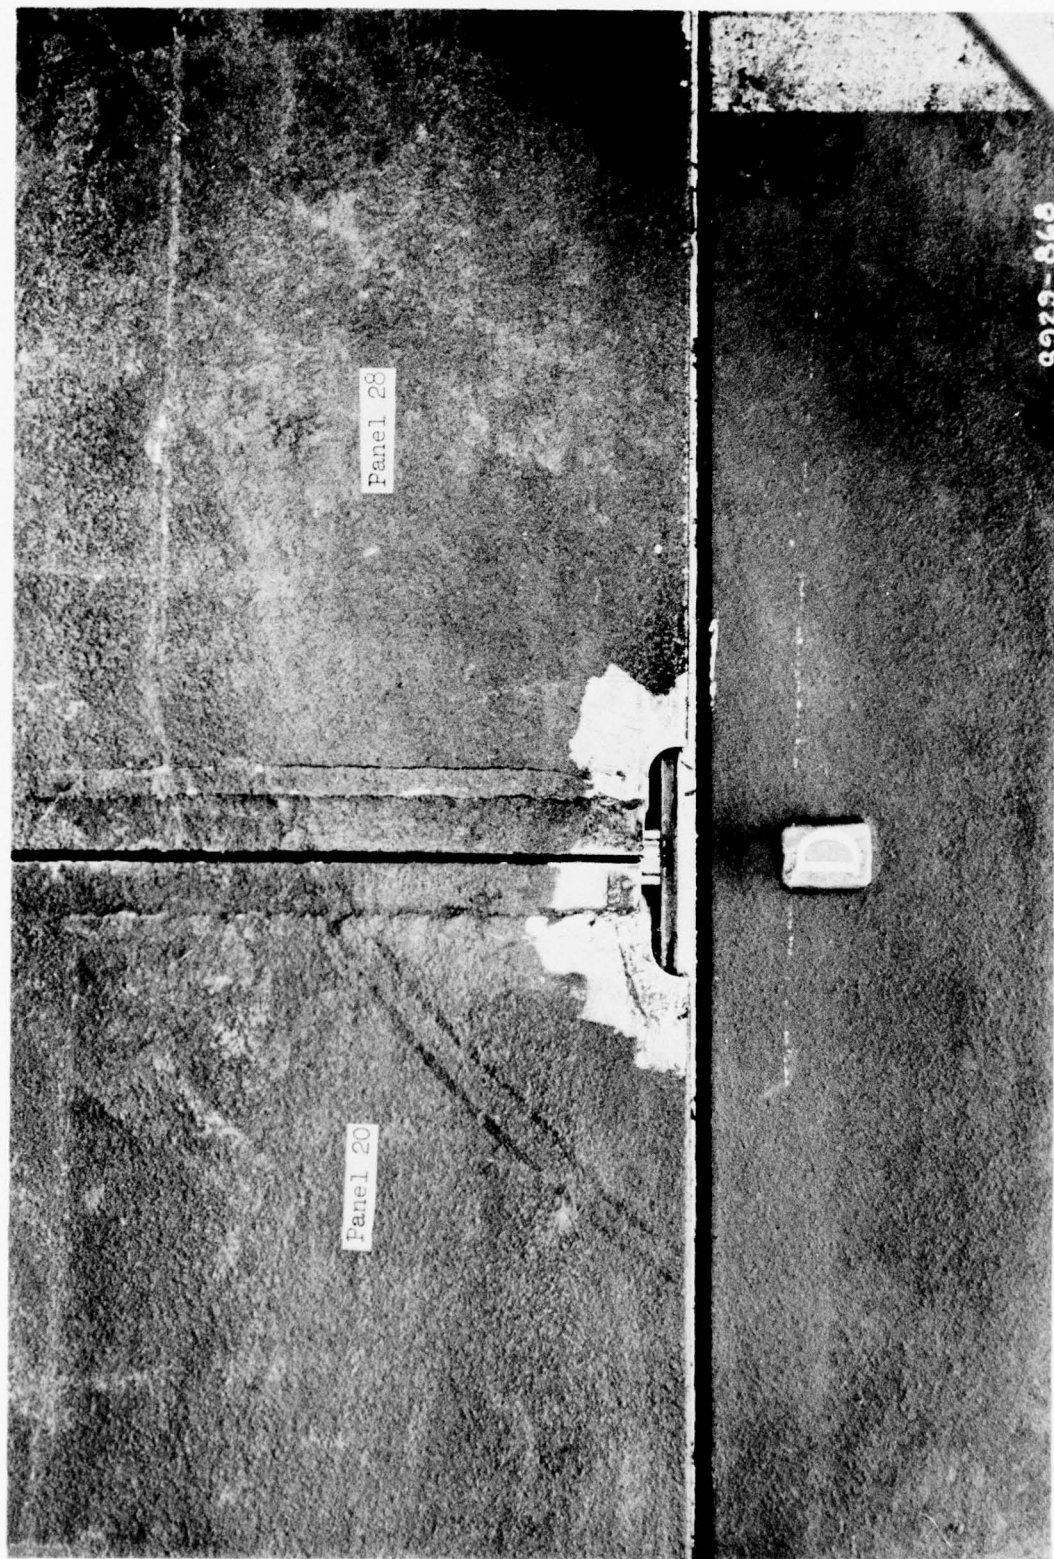
Pair of panels with a 1/2-in. radius at the female corner

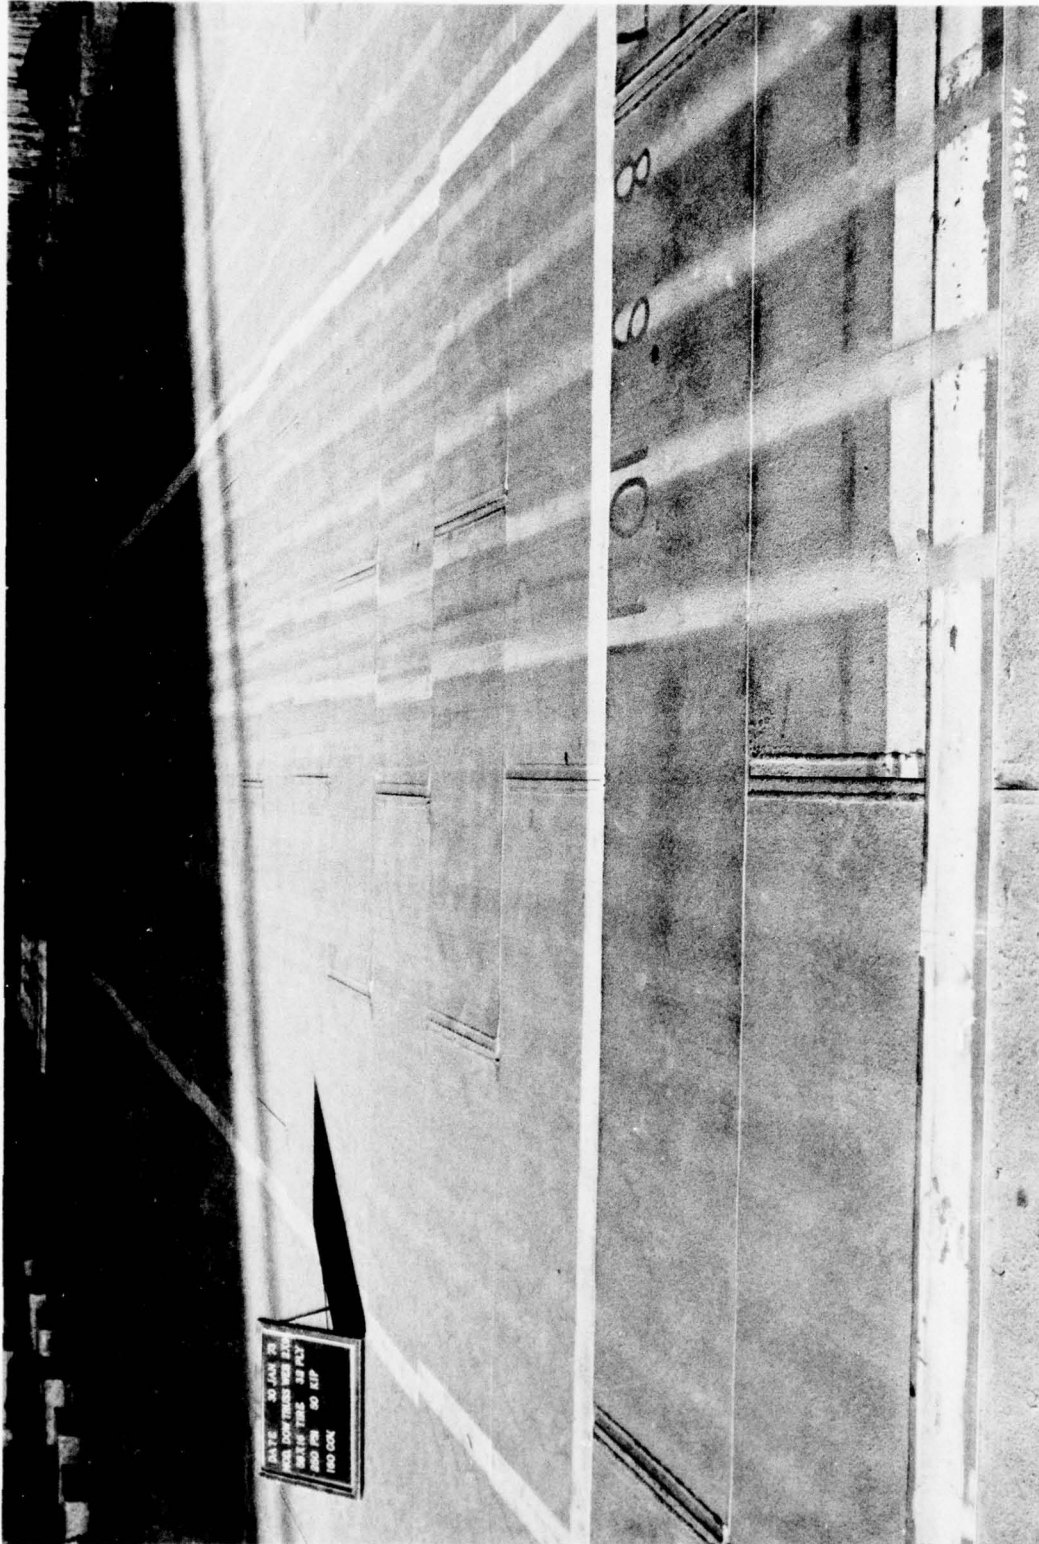
11. The test section prior to traffic is shown on Incl 38. This traffic was applied in the standard pattern and was designated Phase 1. After 90 coverages of traffic, a slight curl was noted in the panels with end joints at the center line of the test section. The test section after 160 coverages of traffic is shown on Incl 39. Typical end joints are

Test section at the end of 160 coverages, Phase 1

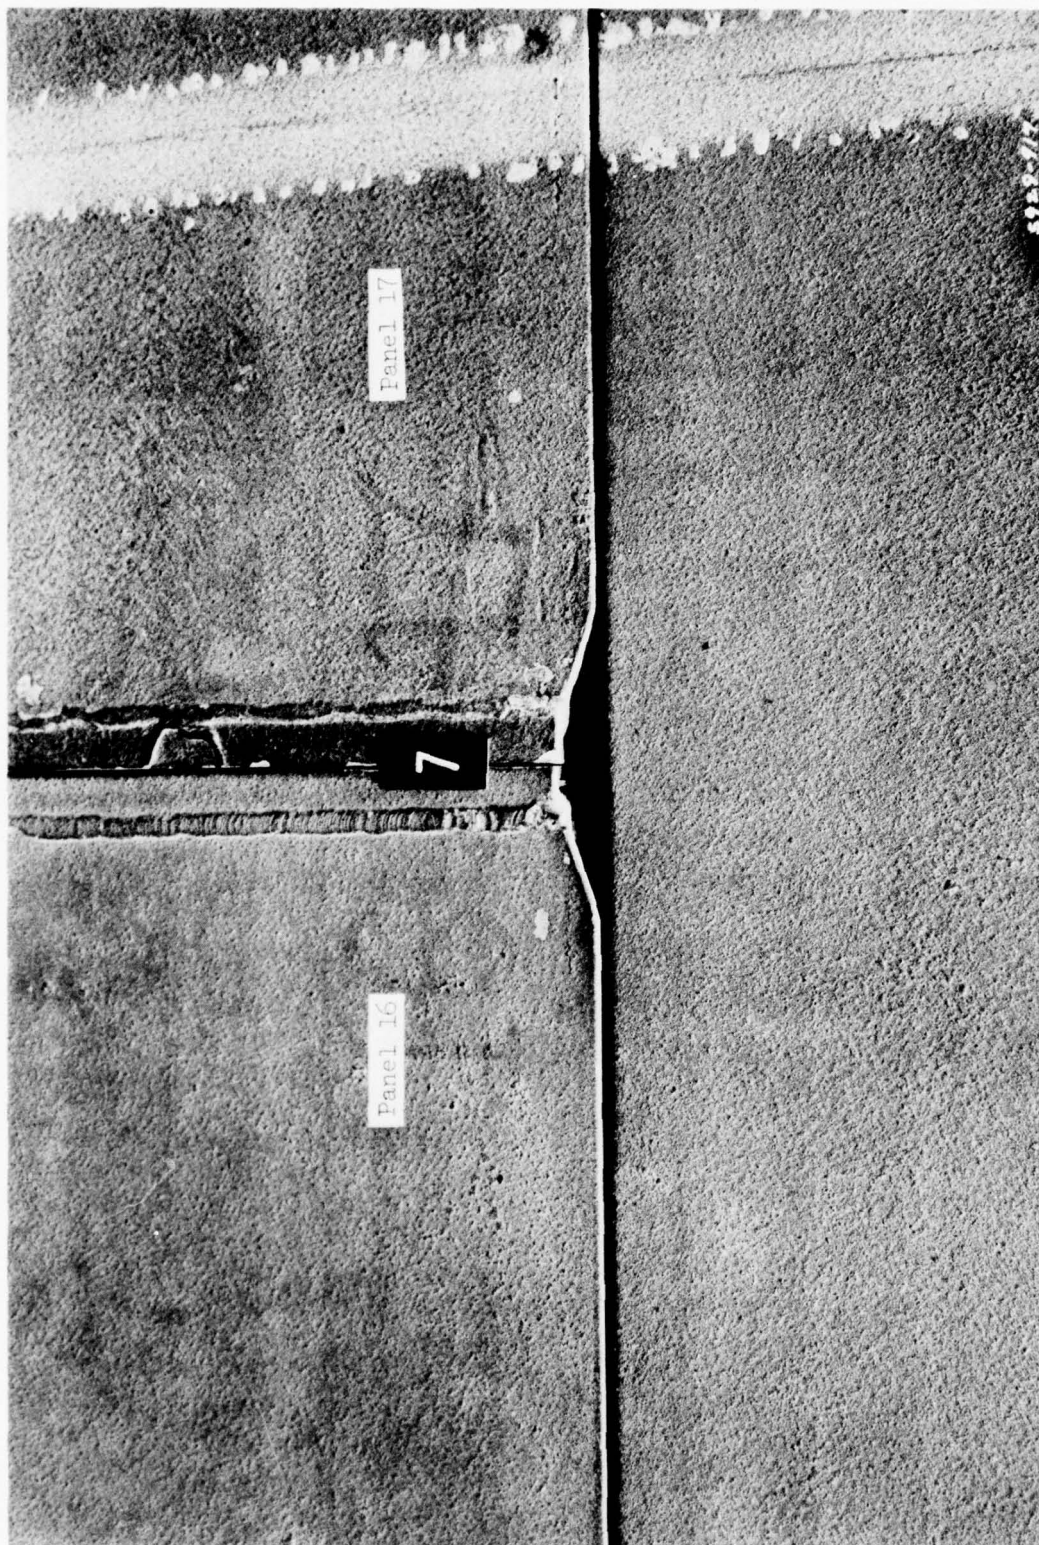
shown on Incl 40. After 310 coverages (Incl 41), four panels had small areas on them where the antiskid had flaked off. There was no noticeable change in the amount of curl; however, the male connectors adjacent to the end joint of two panels were wearing due to the action of the female connectors on the male connector under the load cart. As noted on Incl 41, the mat had shifted and the traffic lanes were misaligned. The weights on the mat edges were removed and the panels were realigned in the traffic lanes.

End joint of panels 16 and 17 after 160 coverages, Phase 1

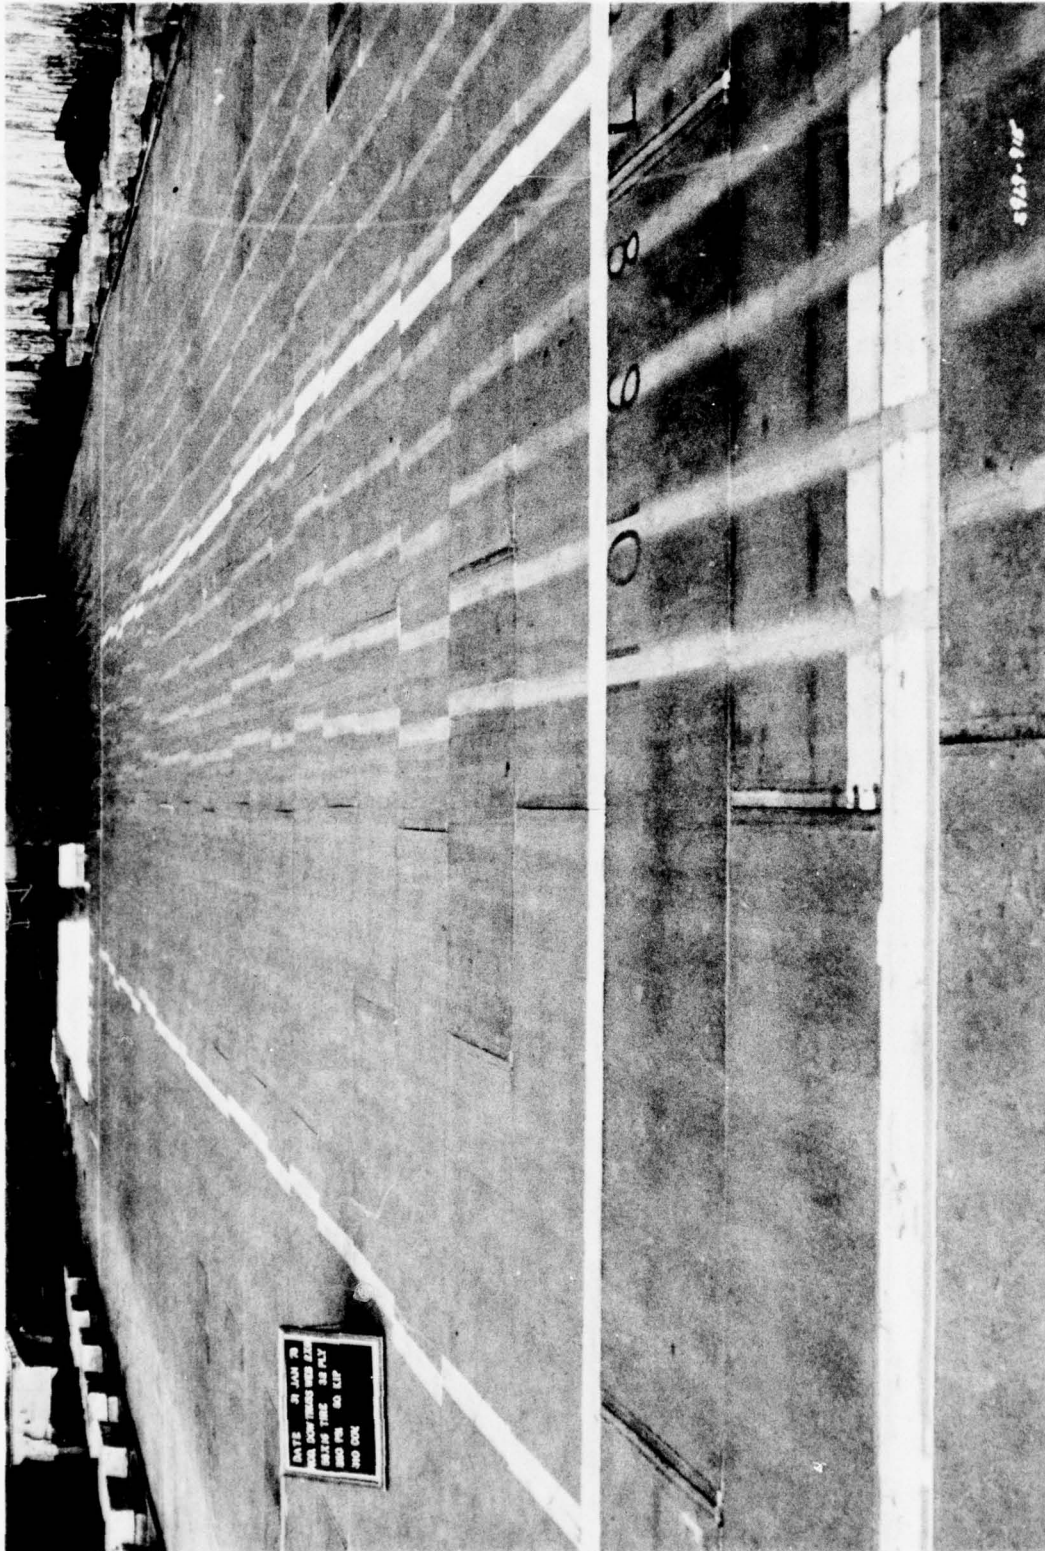
Test section after 310 coverages, Phase 1

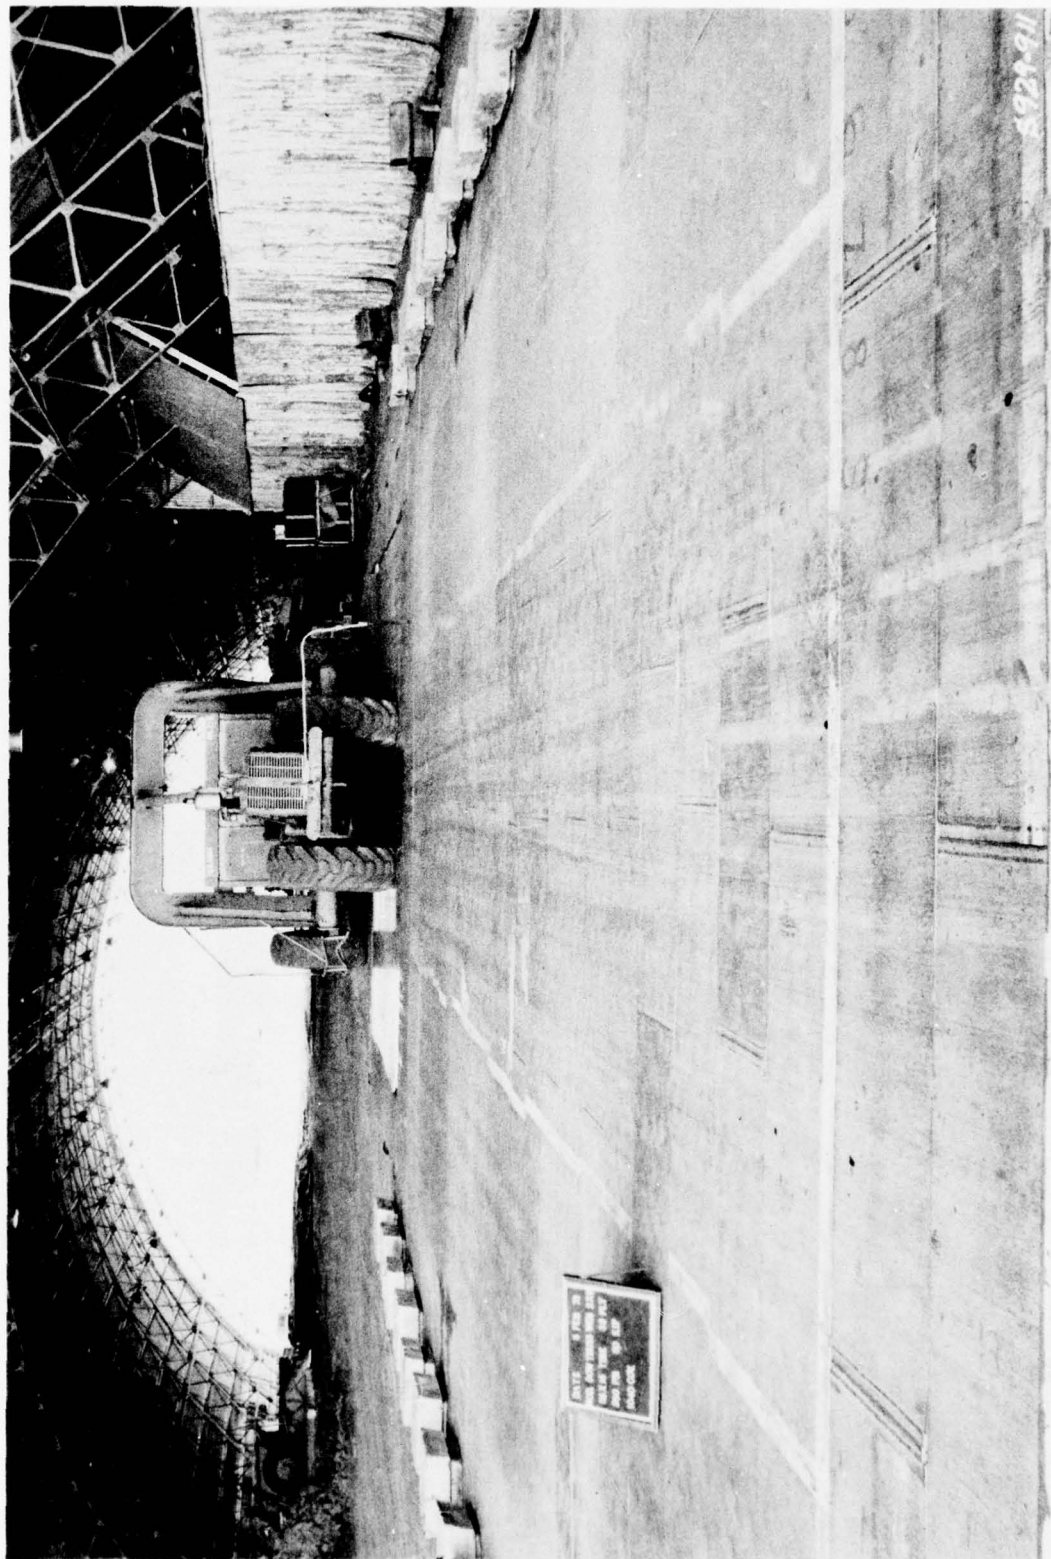
14. At the end of 1040 coverages (Incl 49), CBR data were taken under panel 14 (Incl 37). The rated CBR of the subgrade through 1040 coverages (Phase 1) was 4.0. There were no other failed panels at this time. However, three panels (panels 2, 4, and 13) contained hairline cracks in the female I-lock corner weld, two panels (panels 41 and 49) contained cracks in the weld at the male I-lock corner with the longest being 5-1/2 in. (panel 41, Incl 50), and two panels (panels 21 and 36) were split along the female connector at the female I-lock corner. The split in panel 21 (Incl 51) was 5-5/8 in. The corners of half panels (panels 4a and 9a) were curled along the female connector with one end of panel 9a (Incl 52) split for 3-1/2 in. along the female connector.

Test section after 1040 coverages, Phase 1

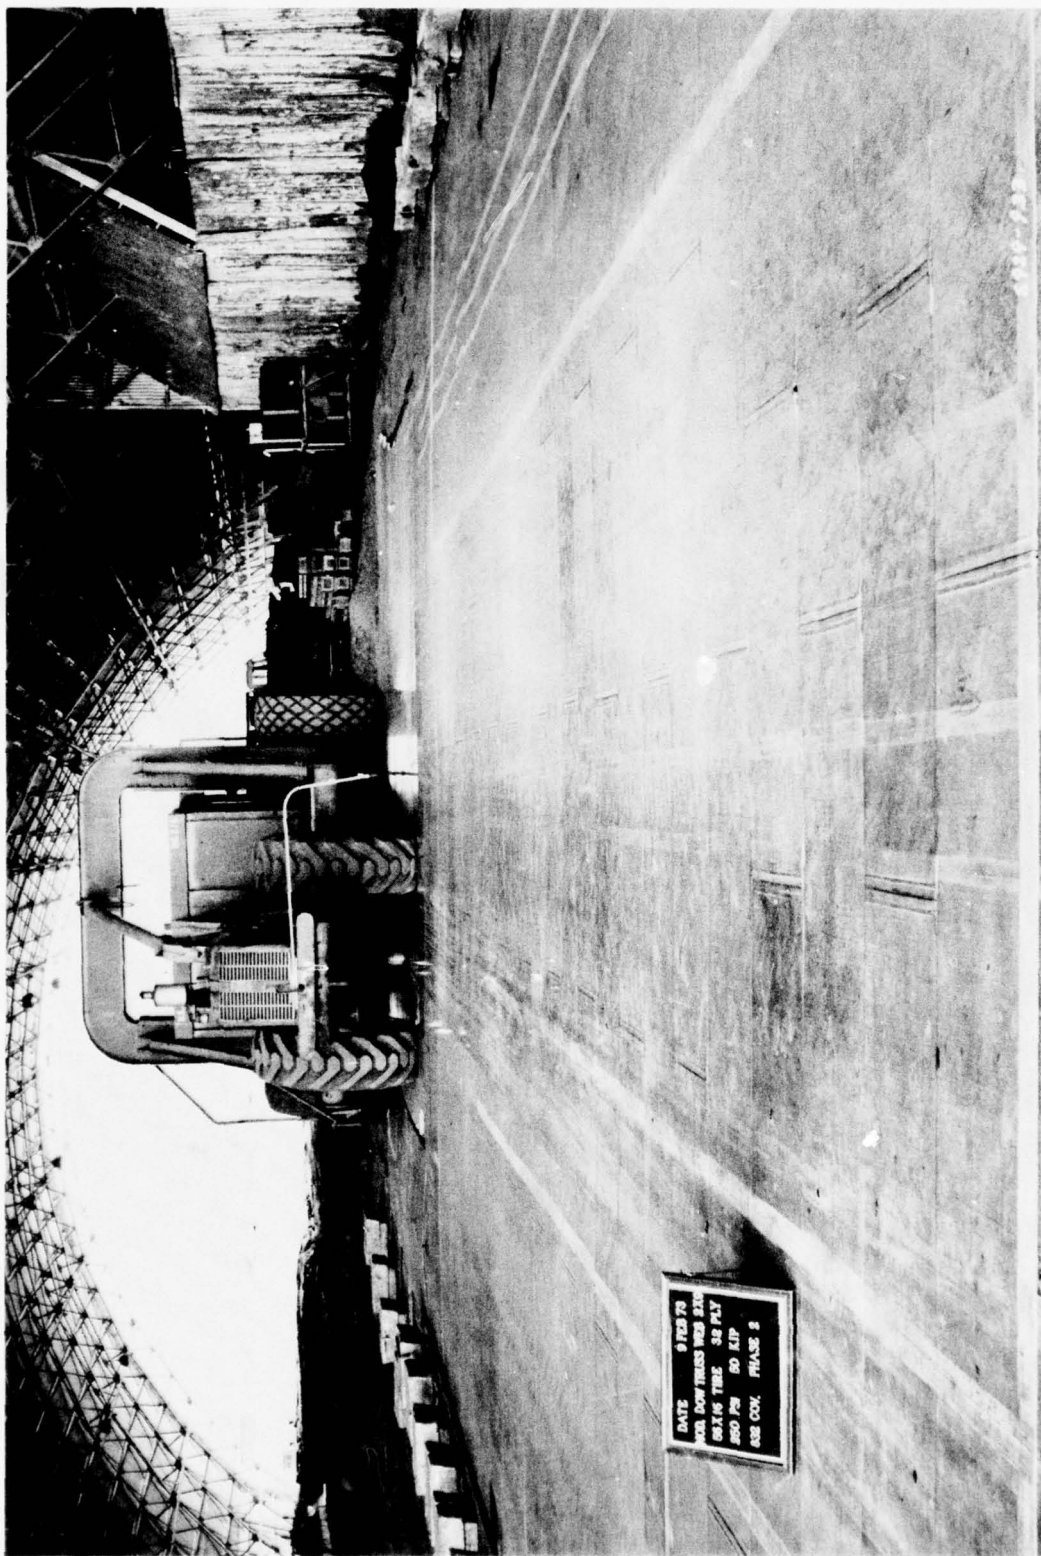
Test section after 832 coverages, Phase 2

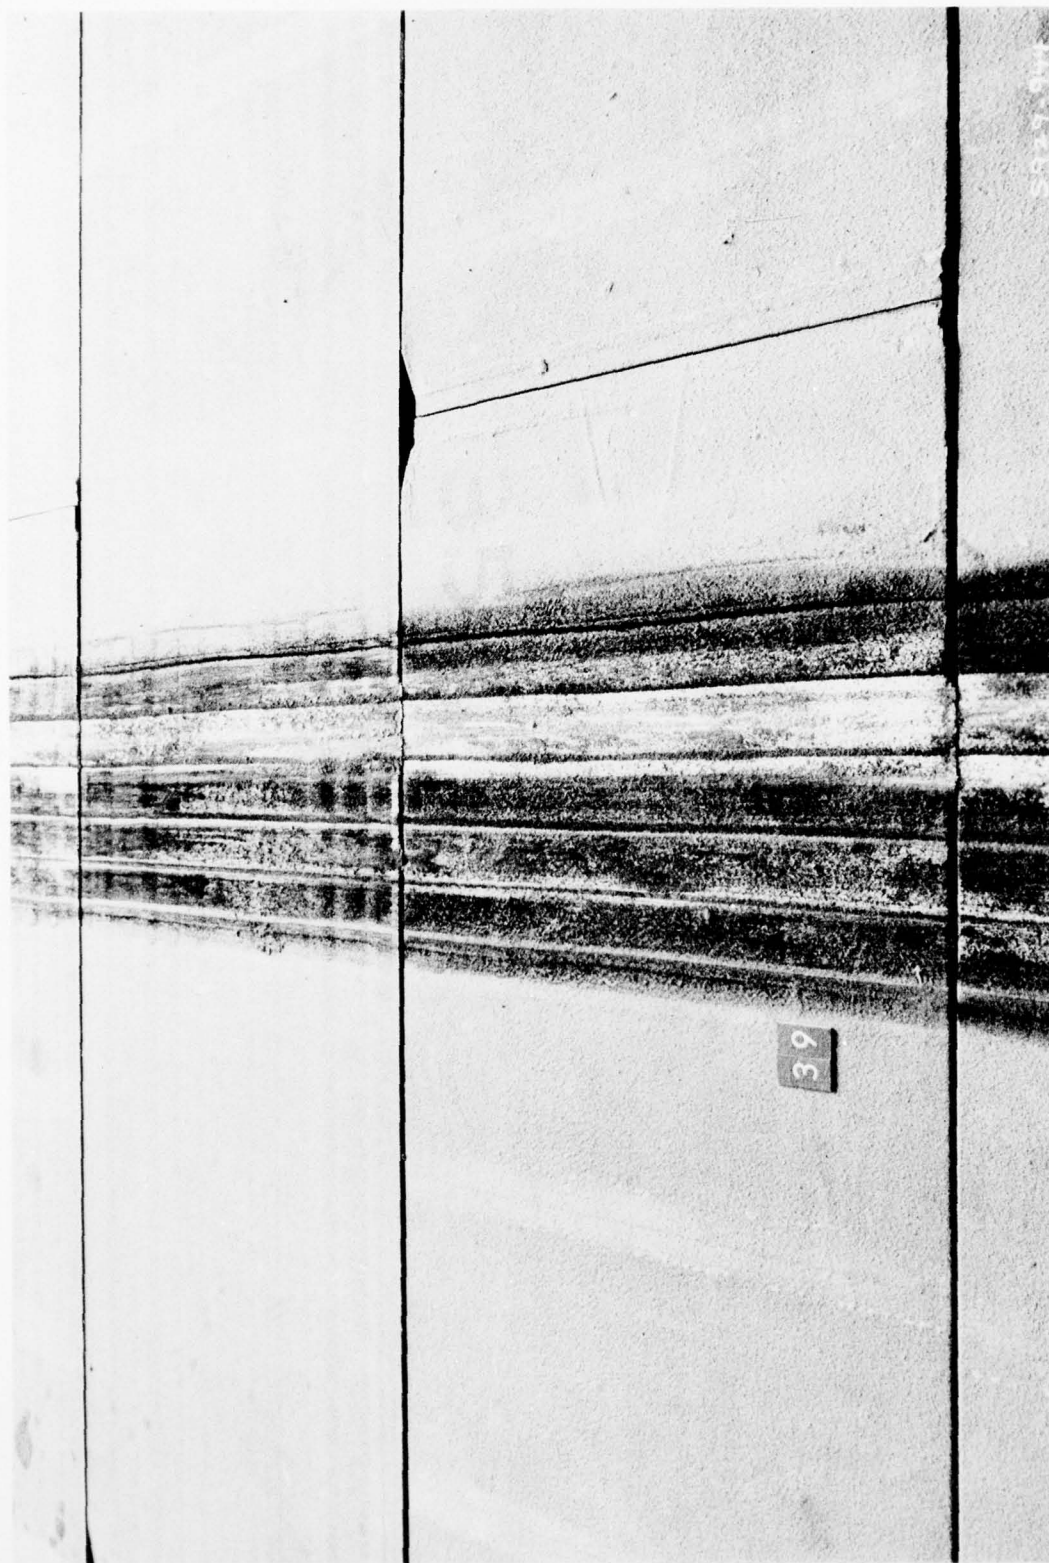
Skid tests conducted on this mat resulted in values for the coefficient of friction on wet (0.40) and dry (0.62) surfaces that meet the requirements of the revised Qualitative Materiel Requirement (runway condition reading of 13-25 or coefficient of friction of 0.40 to 0.80).

Mat surface after dry skid

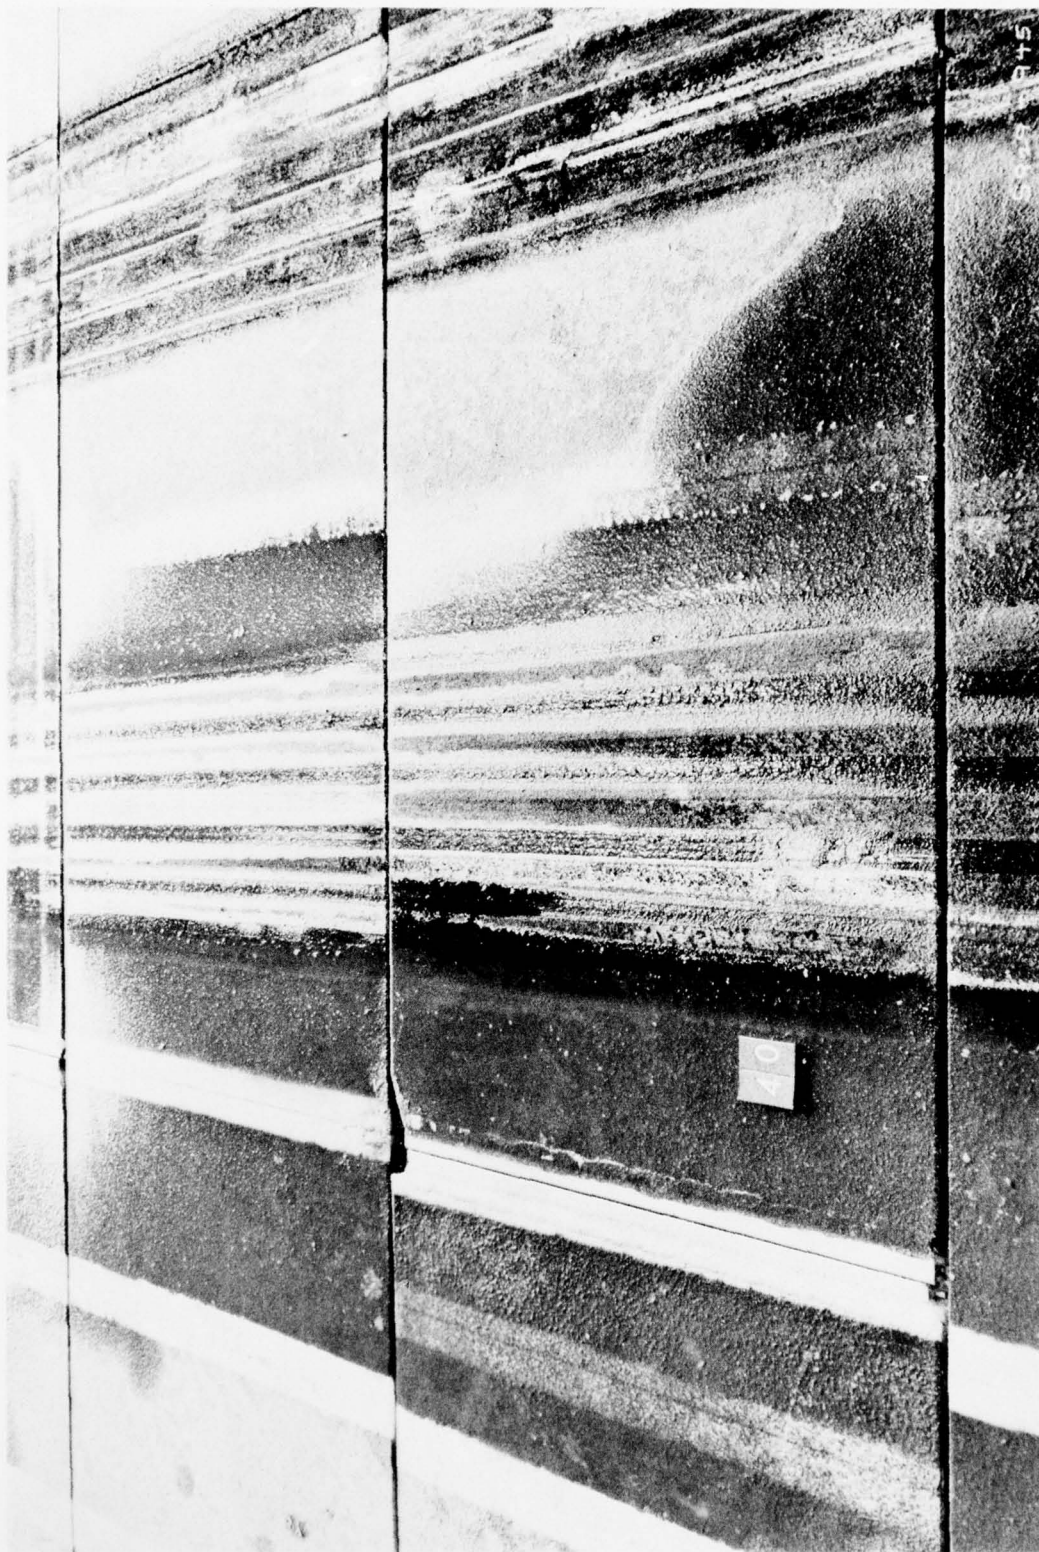
Mat surface after wet skid

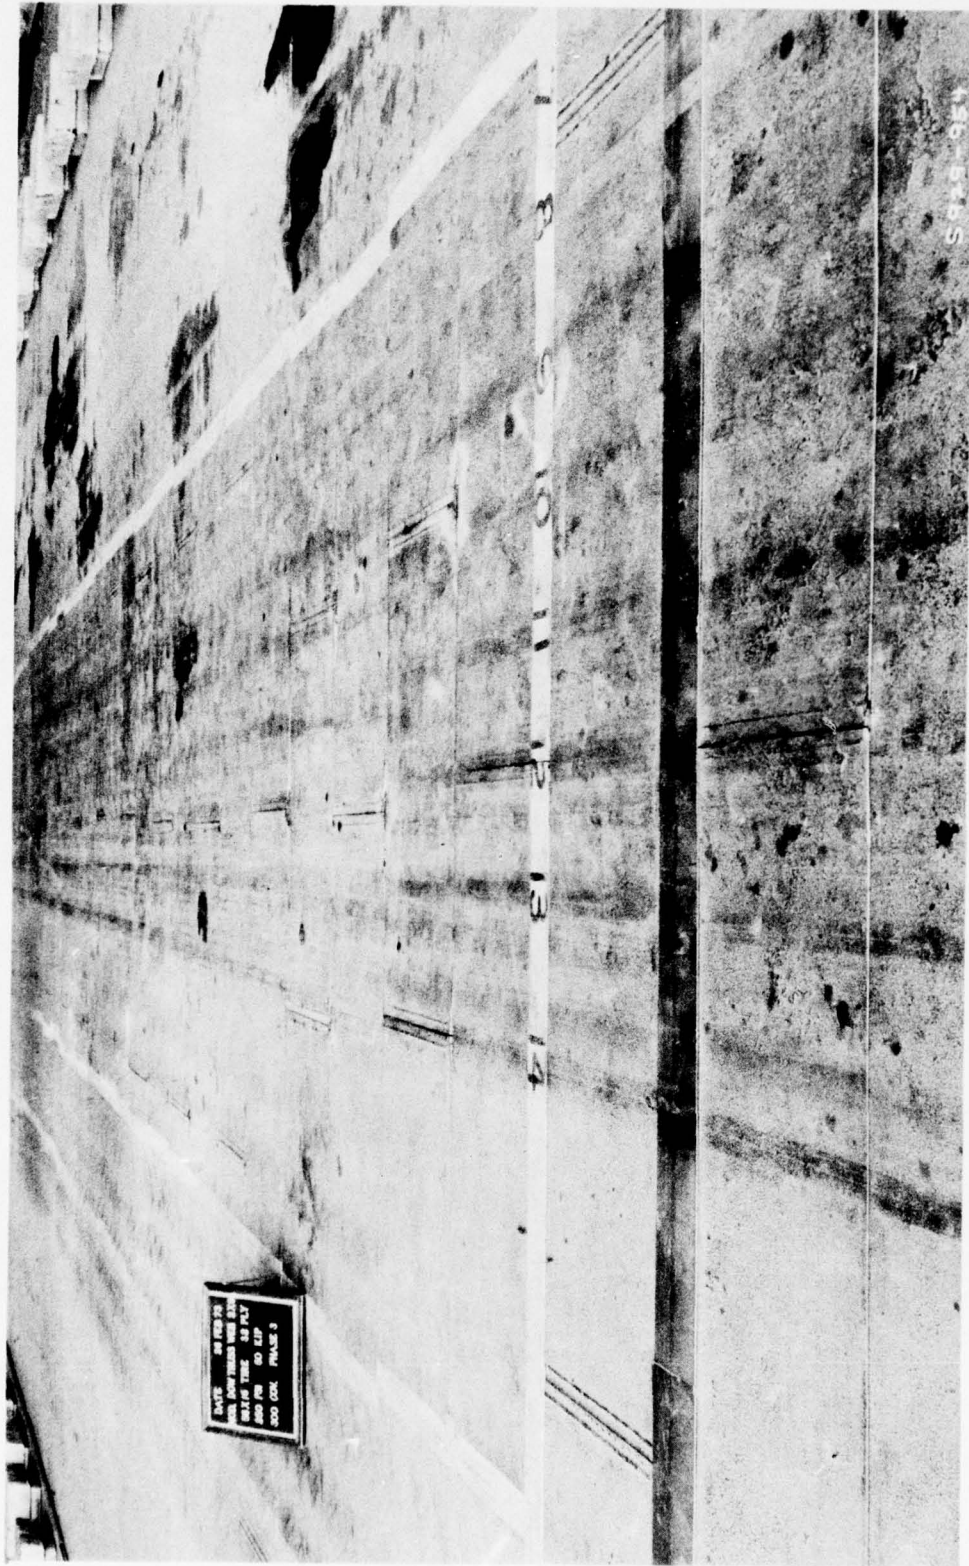
21. The test section at 0 coverage, Phase 3 traffic, is shown on Incl 70. Traffic was continued until 300 coverages were completed (Incl 71). The test section was failed at this coverage level as five additional panels (in addition to the four failed during Phases 1 and 2 traffic) were tire hazards. These panels were 2, 4, 36, 41, and 47, and failure resulted from tire hazards due to splits and sharp edges exposed to the tire. The splits and weld cracks in panels 2, 4, 36, and 41 are shown on Incls 72-76, respectively. Panel 47 was split along the female connector similar to panel 2 (Incl 72). Several panels had areas where the antiskid

Test section after 300 coverages, Phase 3
